3/19/92 - VSI at Ridgefield Brick & Tile Co. fill - Pacific Wood Treating Landfill

RCRA PRELIMINARY ASSESSMENT
PACIFIC WOOD TREATING/RIDGEFIELD BRICK AND TILE
RIDGEFIELD, WASHINGTON
EPA I.D. NO. WAD009036906

VSI PHOTOGRAPH LOG

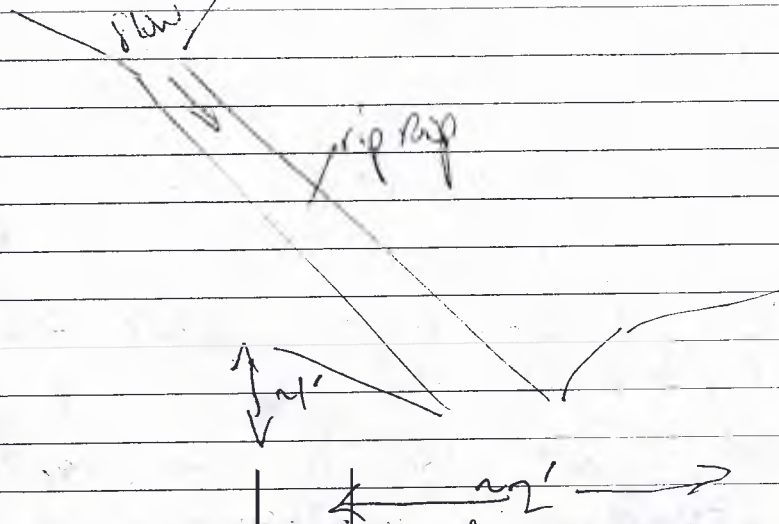
run on diversion - ditch system on east, north & south sides of landfill - ~1 foot deep

~2' wide - has rip rap - in bottom

- moderate rain falling - flow observed in diversion ditches

ditches maintained in good condition -
 - no slumping, gullies or rills noticed

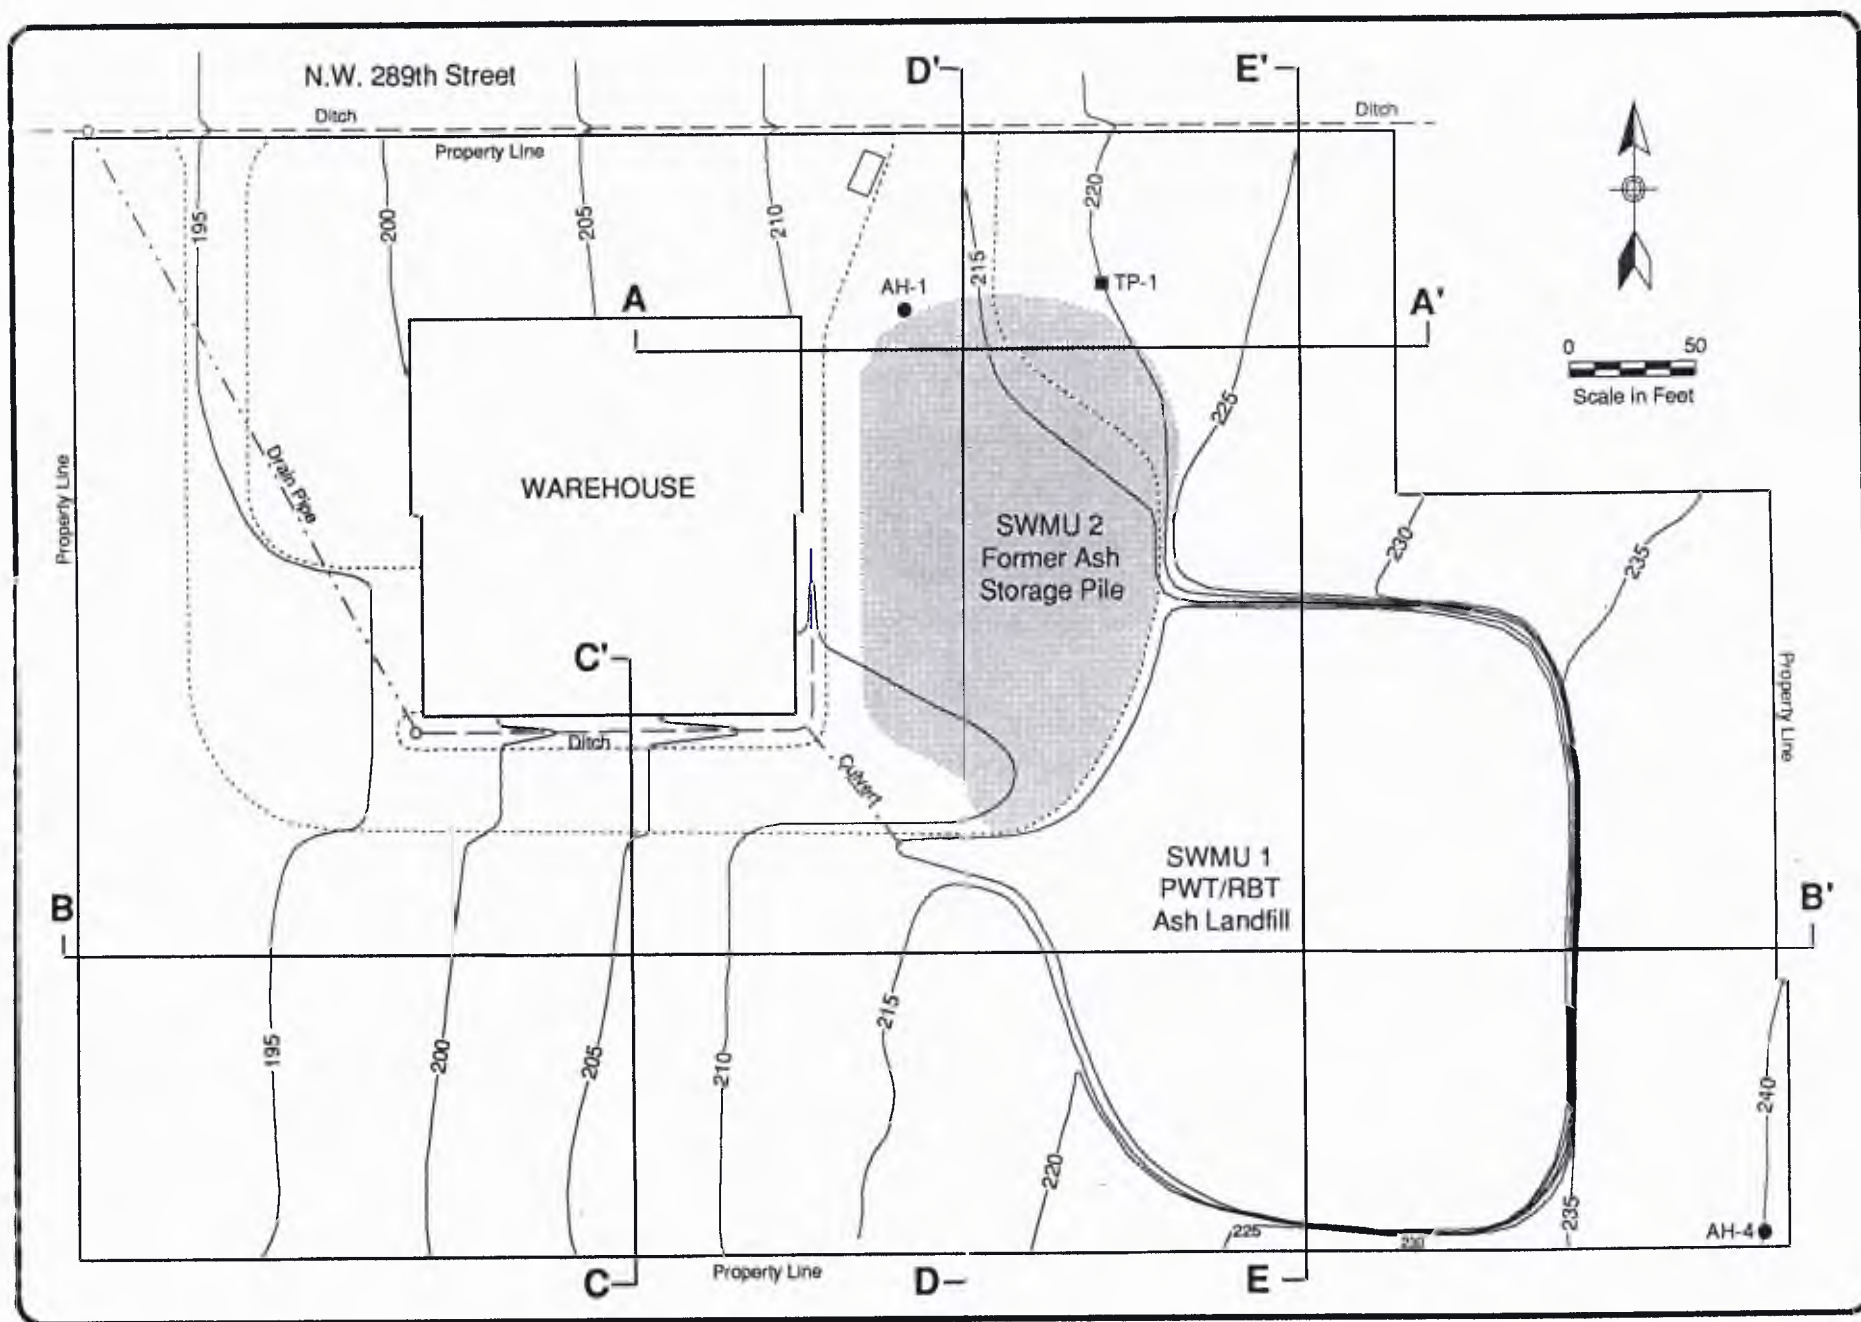
Figure 2

During the course of this assessment, two SWMUs were identified. These units are the landfill (SWMU 1) and the former ash storage pile (SWMU 2). Locations of the SWMUs are shown on Figure 2. Because the facility is an off site disposal unit for wastes that were generated at the PWT wood treating facility in Ridgefield, no other SWMUs are present at the PWT/RBT landfill site.

LOCATION OF SOLID WASTE MANAGEMENT UNITS AT THE PWT/RBT SITE

Two SWMUs were identified and evaluated at the PWT/RBT Landfill site (Figure 2). The following sections provide descriptive and historical information on each SWMU, including an evaluation of their release potentials to all media of concern.

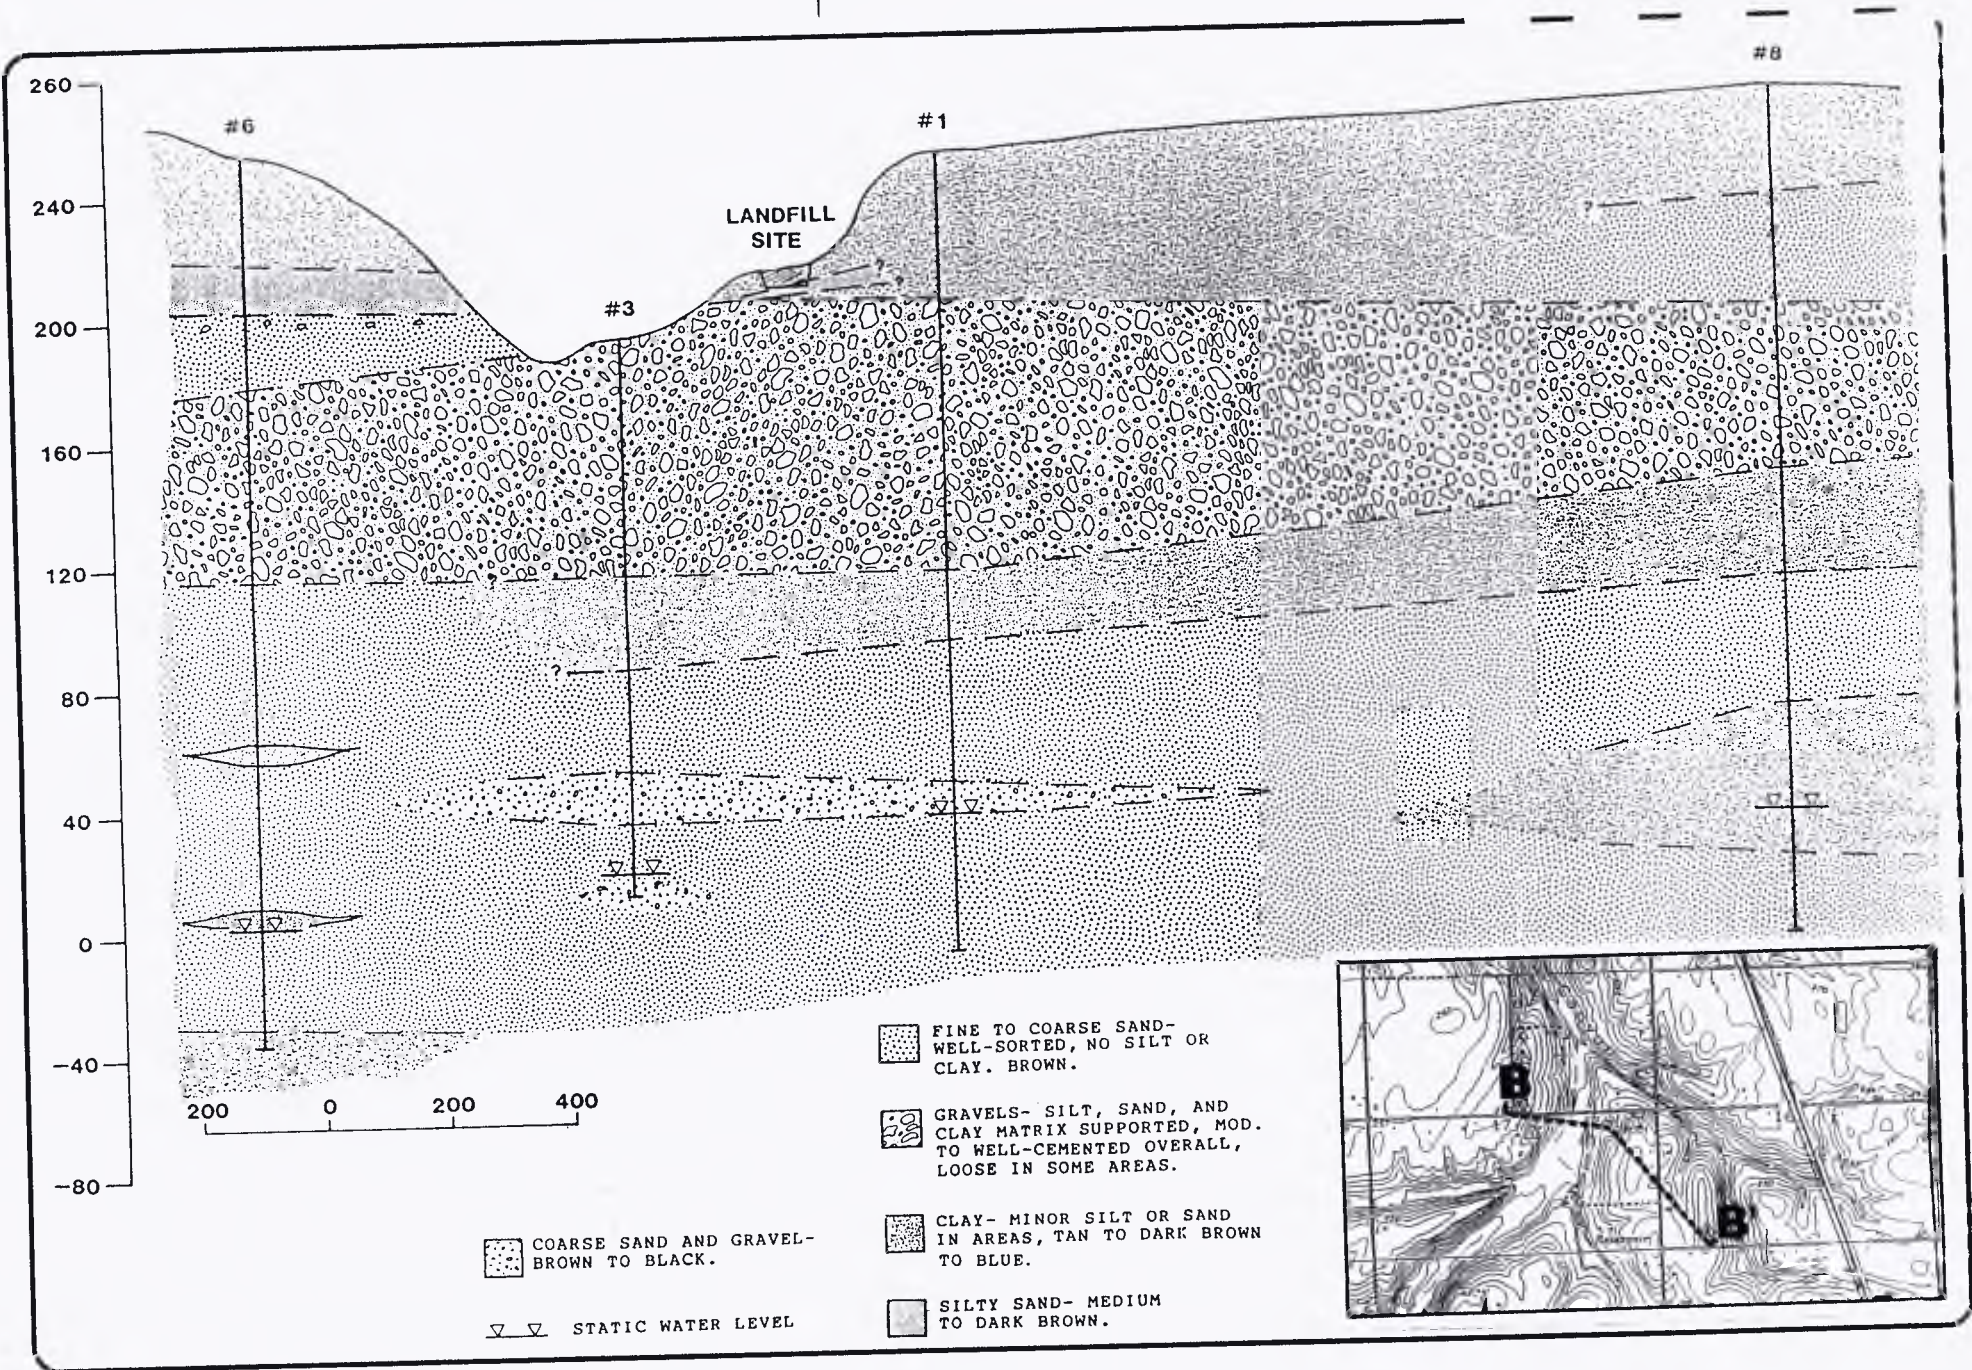
Figure 3

The PWT/RBT site is located in the "Fourth Plains" terrace of southwestern Washington, between the alluvial valley of the Columbia River to the west and the foothills of the Cascade Range to the east. The site is underlain by unconsolidated Quaternary sediments of alluvial and deltaic origin. The unconsolidated deposits are underlain by the Pliocene Troutdale Formation in this portion of Clark County, and the Troutdale Formation is exposed in the valley of the unnamed creek west of the PWT/RBT site. The Troutdale Formation is comprised of an upper gravel member and a lower sand and silt member. Sand interbeds in the lower member of the Troutdale formation serve as the primary water supply in the vicinity of the PWT/RBT site (Figure 3). Older consolidated rocks underlying the Troutdale Formation are Eocene to Miocene volcanic and sedimentary rocks. These formations do not serve as significant aquifers in western Clark County due to the depths (several hundred feet below land surface) and low yields of these units.(2,3,4,5,17,19,20)

Subsurface soil samples collected at the site from the unconsolidated Quaternary sediments have been classified as stiff silty clay, silty micaceous sand and well sorted sand. The silty clay unit is up to 40 feet thick at the site, and the silty clay overlies the sand interval at the eastern side of the site. The lower sandy interval thins to the west, and pinches out west of the landfill (Figures 4,5,6). The excavation for the landfill was formed during quarrying of the silty clay for brick and tile manufacturing. The bottom of the excavation is at the top of the sand interval; the downward advancement of the pit was halted at the clay - sand contact.(3,4,5,10)

The Troutdale Formation of Pliocene age underlies the Quaternary sediments across the site and adjacent areas. The upper portion of the Troutdale Formation penetrated by borings at the site is a silty sandy gravel. The gravel clasts of the conglomerate beneath the upper contact have been weathered to clay. Weathering of rock clasts in the upper portion of the Troutdale Formation is common in the area, often resulting in a significant increase in the clay content of the unit. The alteration of the gravels of the uppermost Troutdale Formation at the site has reduced the hydraulic conductivity to less than 10^{-5} cm/sec.(2,10)

REGIONAL GEOLOGIC CROSS SECTION OF THE PWT/RBT SITE
Source: Reference 14

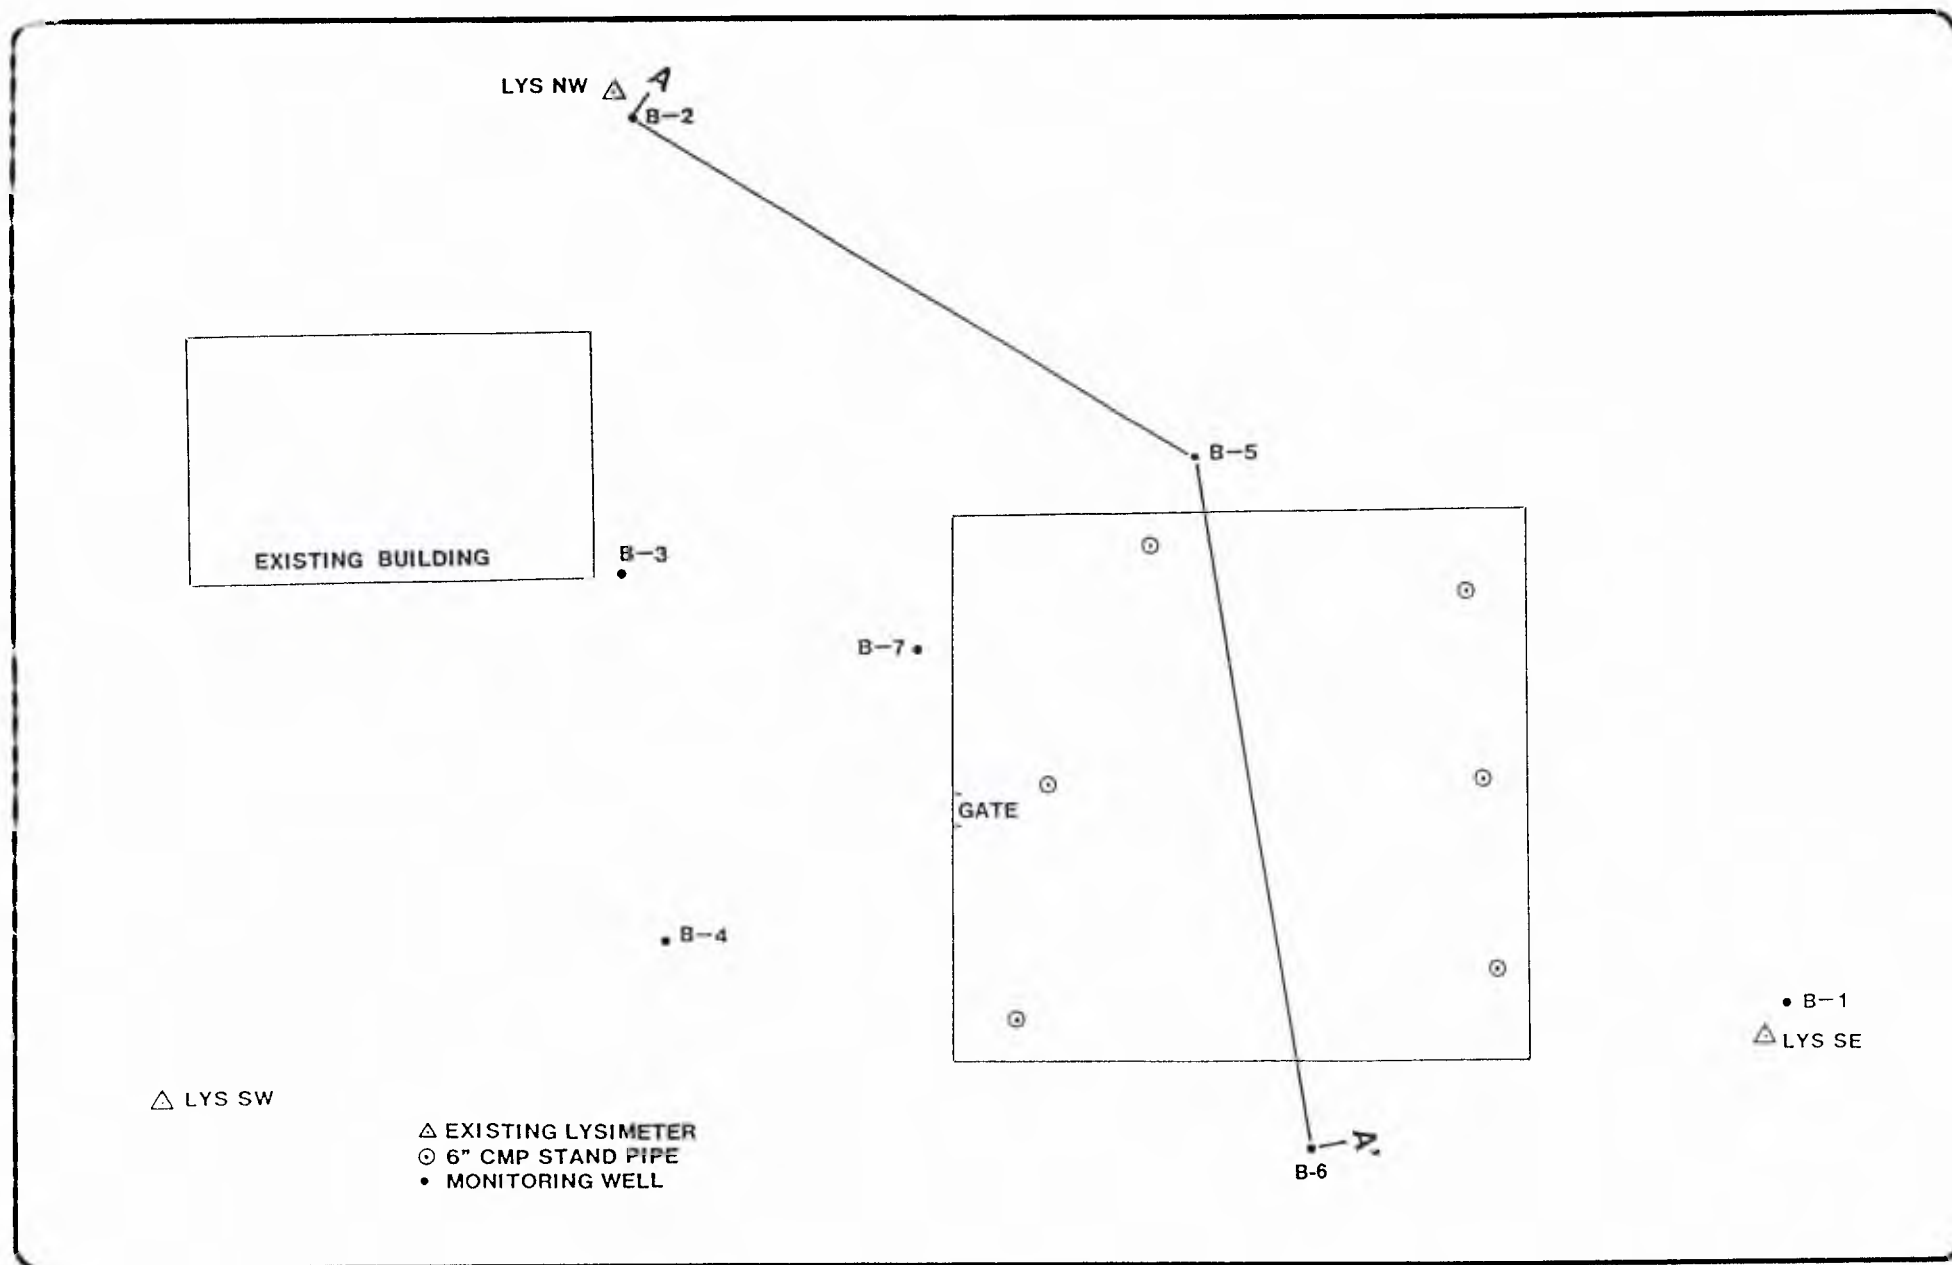
Figure 4

MONITORING WELL AND CROSS SECTION LOCATIONS
PWT/RBT LANDFILL SITE

In August of 1987, seven monitoring wells were installed at the landfill. The wells were completed with screened intervals placed in the sand present in the lower portion of the unconsolidated sediments, except where the sand is absent to the west of the landfill. Monitoring well completions are illustrated in Figure 5. Where the sand was not present, the monitoring wells were completed in the uppermost portion of the Troutdale Formation. Water level monitoring conducted in the newer monitoring wells indicated that the lowermost part of the sand unit beneath the landfill (up to one foot thick) is ephemerally saturated during wet season conditions. Because the monitoring wells have been constructed with the sand pack interval across the contact of the Troutdale Formation and the overlying Quaternary sediments, the horizontal flow direction in the sand unit and the hydraulic relationship with the Troutdale can not be determined from available information. Toe drain leachate analyses detected hazardous constituents associated with the wastes in the landfill, including arsenic, pentachlorophenol; however, hazardous constituents have not been reliably detected in any ground water samples collected from the site at levels that indicate that a release has occurred from the unit (see section 3.6).

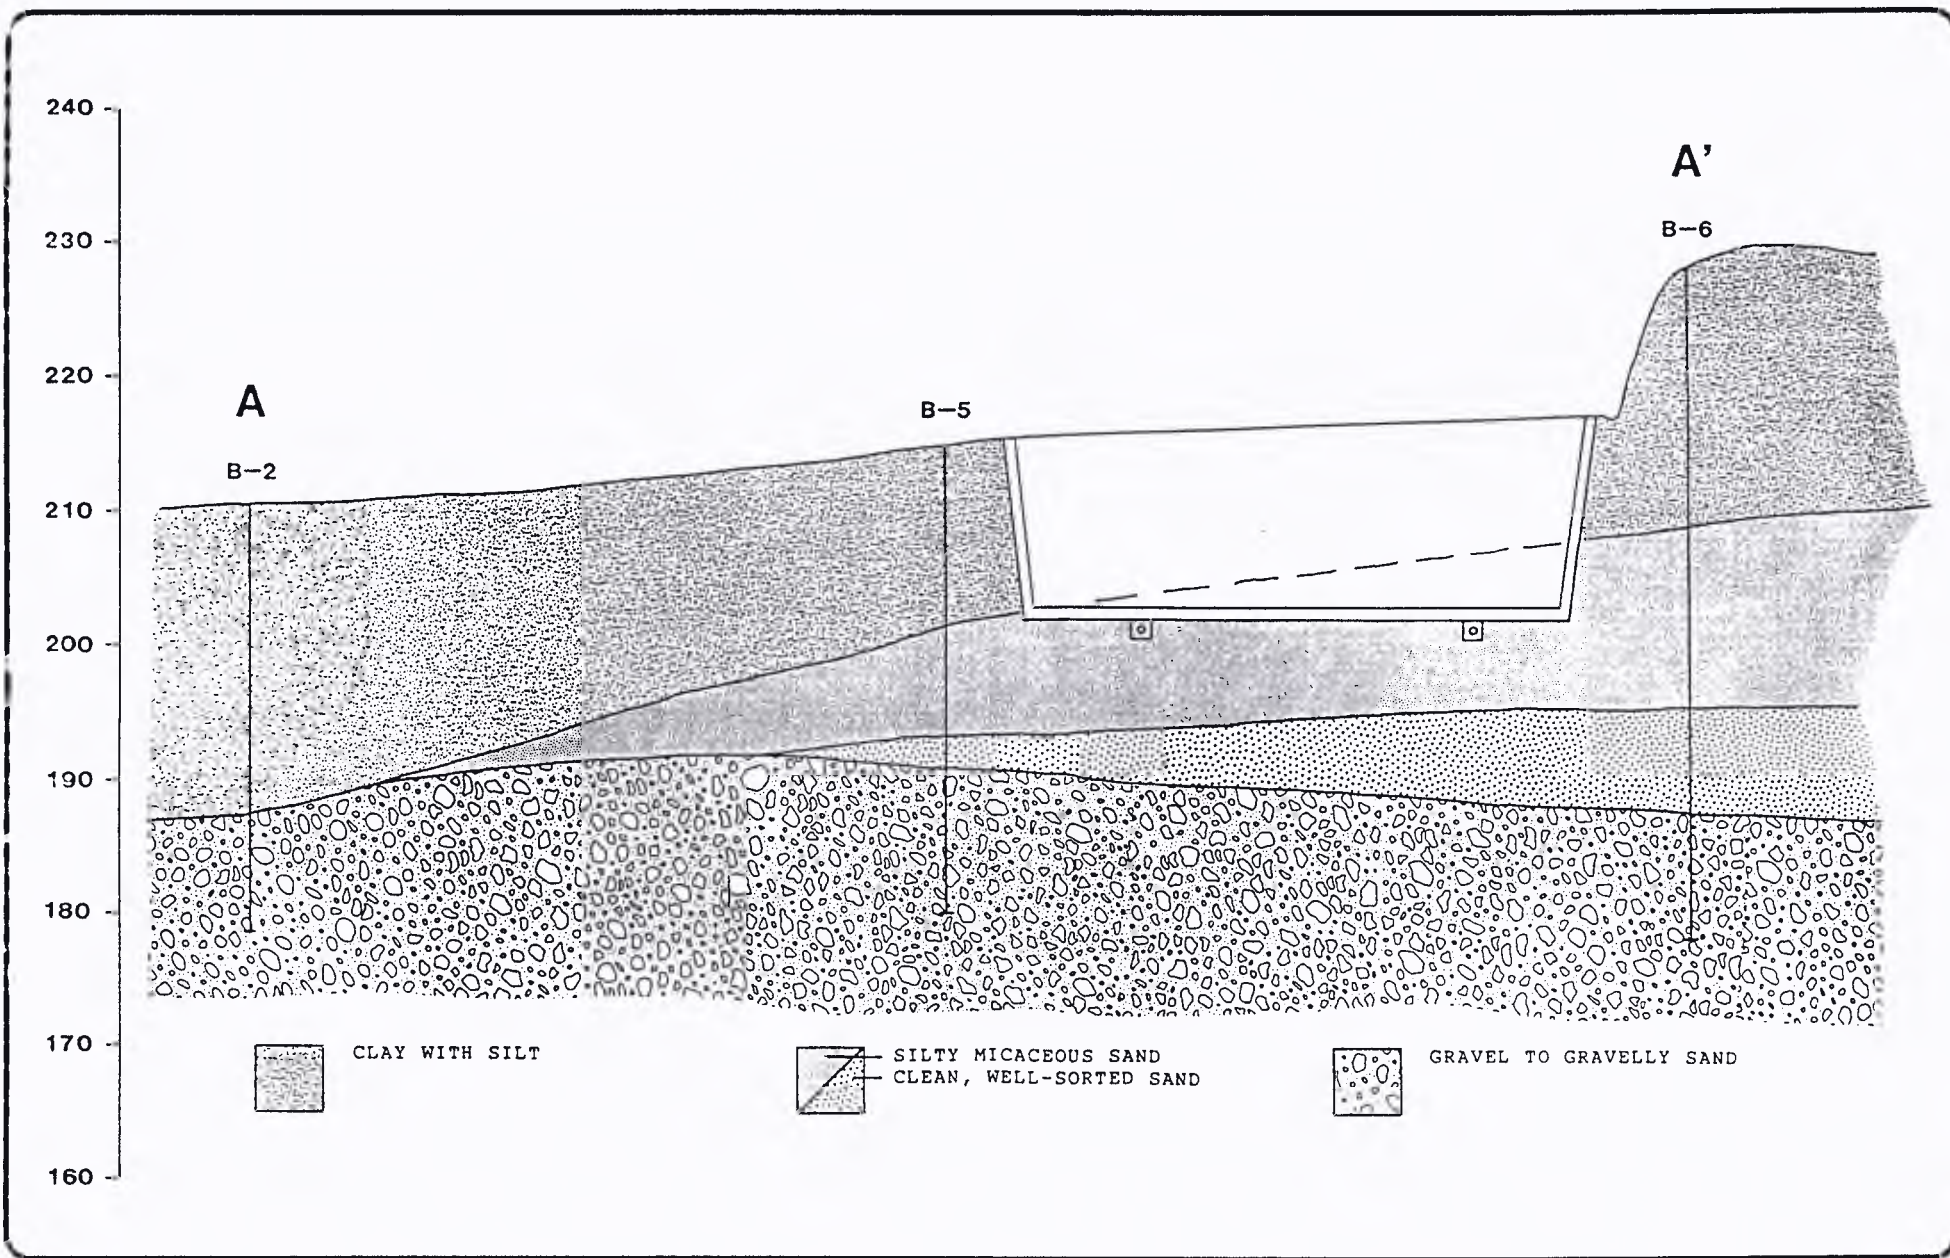
Figure 5

CROSS SECTION OF THE PWT/RBT LANDFILL SITE

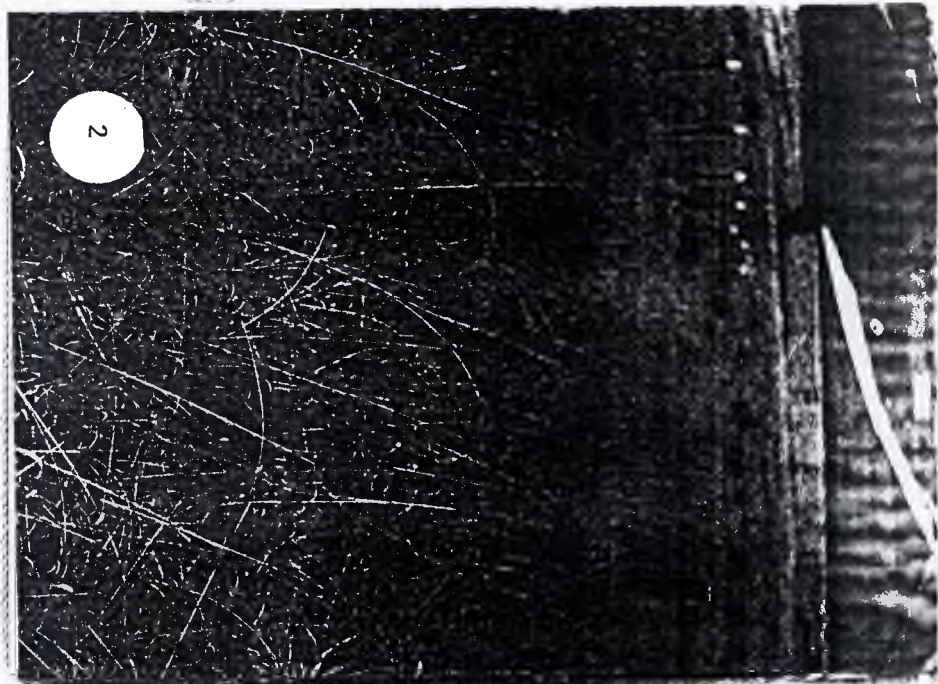
Photo 2 - South side of L.F. run on diversion ditch - flowing water - due to rain fall

| 2. | Run on diversion ditch at south side of landfill (SWMU 2). Note flowing water in ditch. |

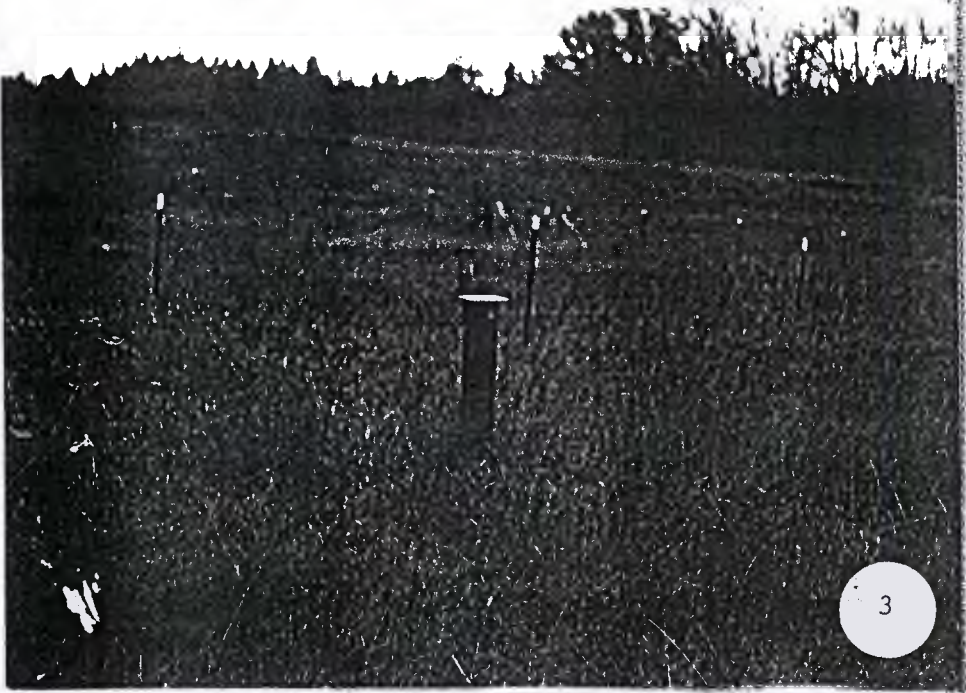
- check monitoring wells
 - seals & casings in good condition.

Photo 3 - monitoring well B-5
(vent in background)

| 3. | Monitoring well protective casing (well B-5). Note vent structure in background. |

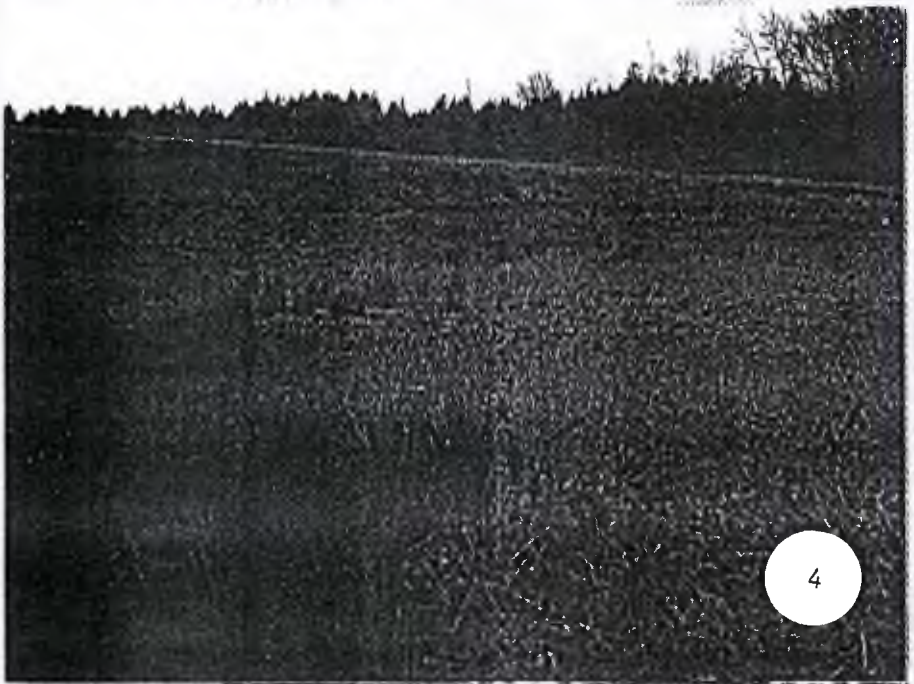
Photo 4 - monitoring wells - west side
of LF.

| 4. | Monitoring wells at west side of landfill (SWMU 1). |

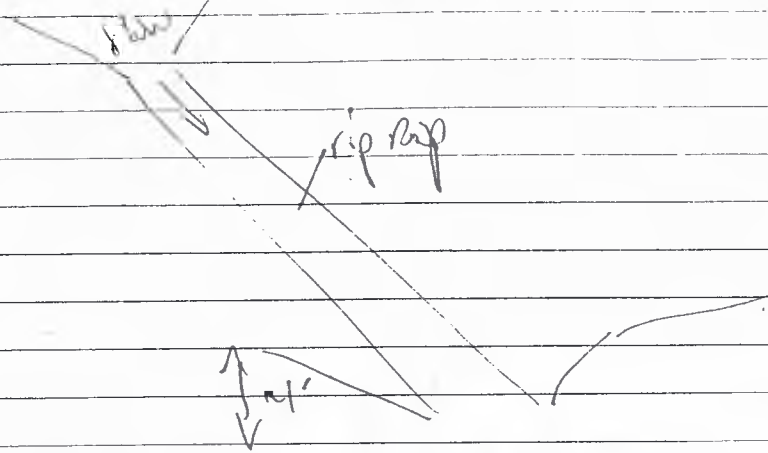
run on diversion - ditch system on east, north & south sides of landfill - ~1 foot deep
~2' wide - has riprap - in bottom.
- moderate rain falling - flow observed in diversion ditches

ditches maintained in good condition -
 - no slumping, gullies or rills noticed
